The Coastal Abrasion Mitigation Using Permeable Structure at The Sipora Island

Herdiana Mutmainah

Keywords: Abrasion mitigation; permeable structure; The Sipora Island.

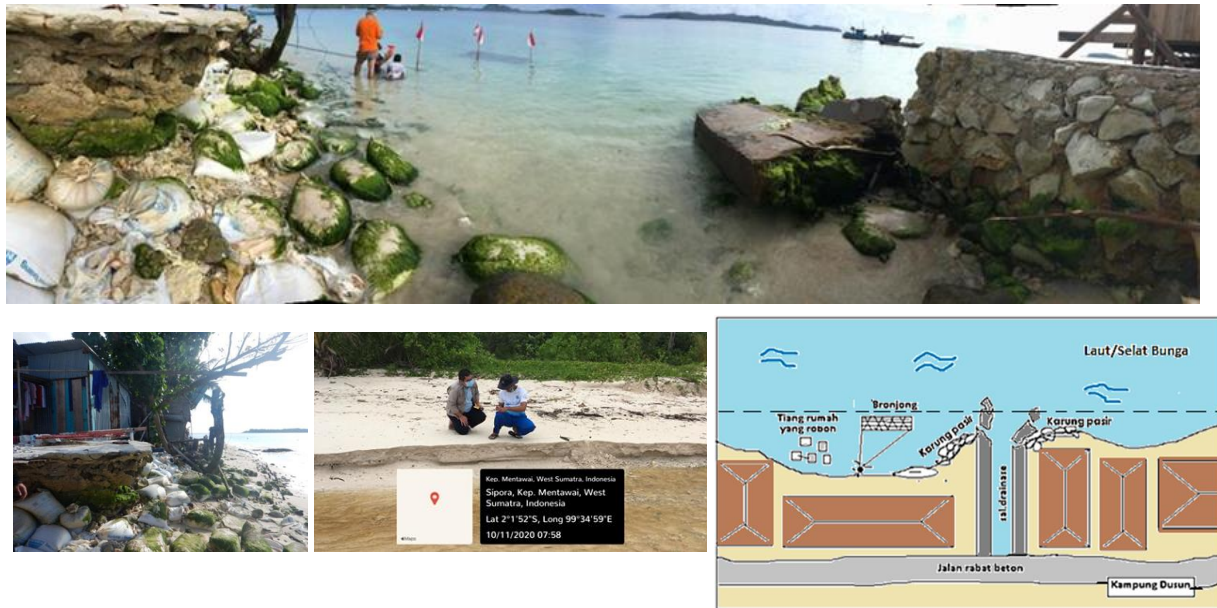
FIGURE 5. Abrasion at Kampung Dusun, Tua Peijat, The Sipora Island

Abrasion at Kampung Dusun is categorized as very high level based on CVI and highly high level based on regulation. The abrasion is 1,608 m² with a rate of 3.73 m/year. To prevent abrasion, the permeable structure shows performance by reducing the sea current velocity and wave pressure. It also creates sediment at the back of the structure, with an average sediment rate of 9.389 cm³/day. The seawater quality shows the sedimentation process by increasing some variables, i.e., turbidity and TDS. The recommendation for the following research is an analysis of abrasion mitigation using hybrid coastal protection.

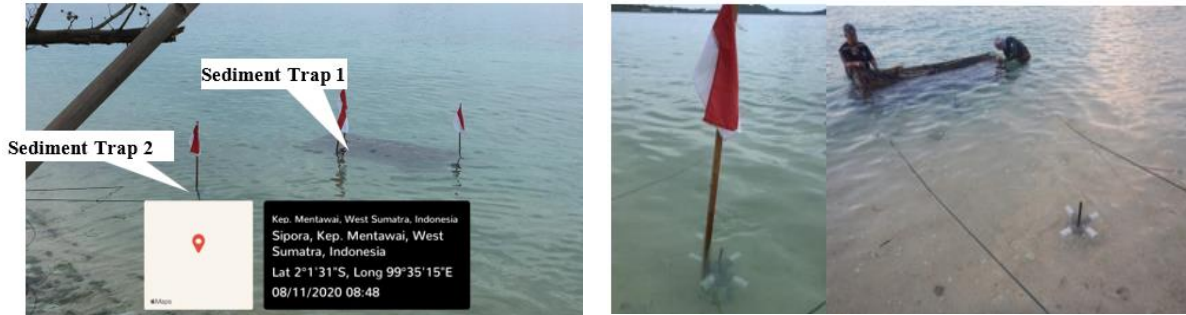
FIGURE 7. The location of permeable structures and sediment traps

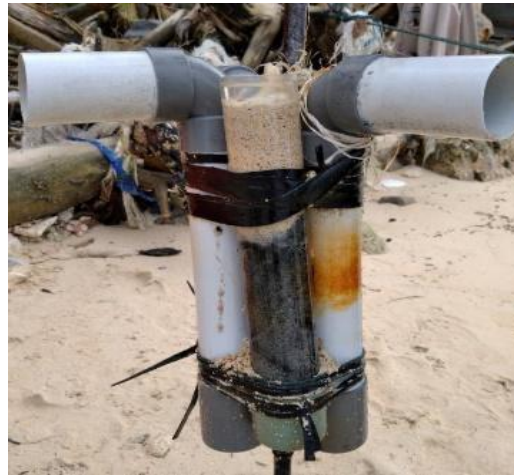
There are two layers, which are sand and mud. The parameter of sediment is seen in TABLE 3.

FIGURE 8. The result of the sediment trap at Point 1

There are 2 (two) points of sediment trap location: Point A1, behind the permeable structure, and Point A2, near the beach. As seen in TABLE 3, the sediment at point 1 was dominated by particles from parallel currents and the beach. Particles from perpendicular current dominated sediment at point 2. The sea current direction is west and east (parallel to the coast). The difference in sediment volume between points 1 (V1) and 2 (V2) is 0.73 cm³/day (V1>V2). The average sediment rate, $v_{s,avr}$, is 9.389 cm³/day. The total time for sedimentation is 115 days or 3.8 months.

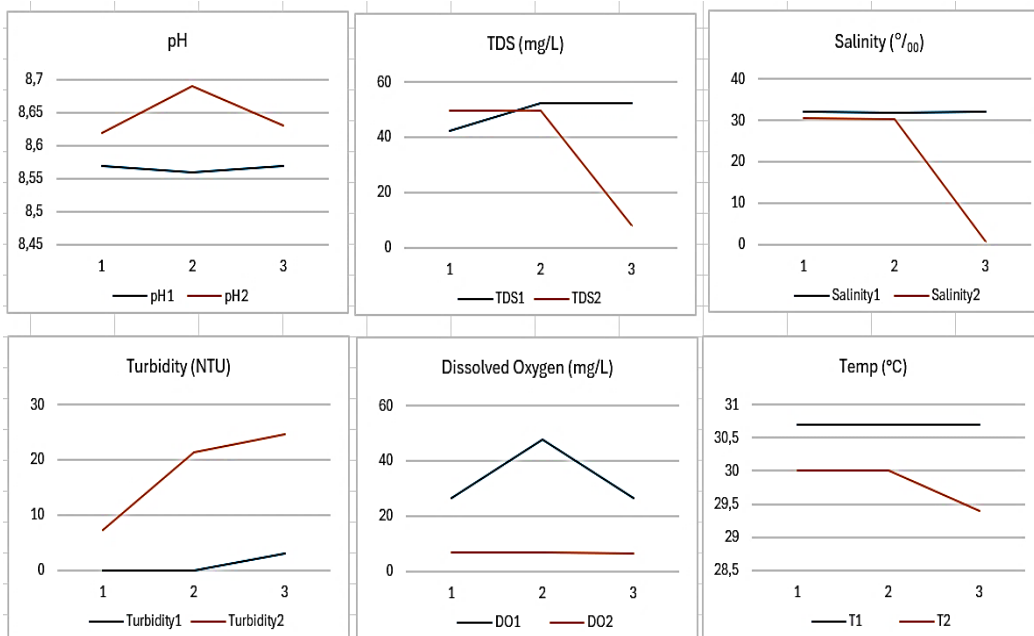
FIGURE 11. The comparison of water quality in the first and second survey

As seen in FIGURE 11, pH and turbidity were increased, and TDS and salinity at some points were relatively stable, but Dissolved Oxygen and temperature were decreased. TABLE 6 shows the current velocity and wave pressure before (without PS) and after PS (with PS) implementation. The result is $v_1 > v_2$ and $P_1 > P_2$.
