## Evaluation of Building Vulnerability to Earthquake Using Rapid Visual Screening (RVS) Method

Based on the above background, the building's vulnerability evaluation to earthquakes using the Rapid Visual Screening (RVS) method applied to a case study of the building dr. Soebandi Jember. So the vulnerability building to earthquakes or safe against earthquakes can be known.

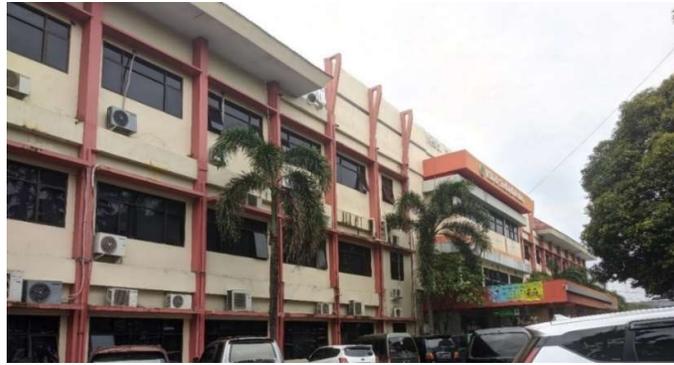
**FIGURE 5.** The front view of dr Soebandi's building

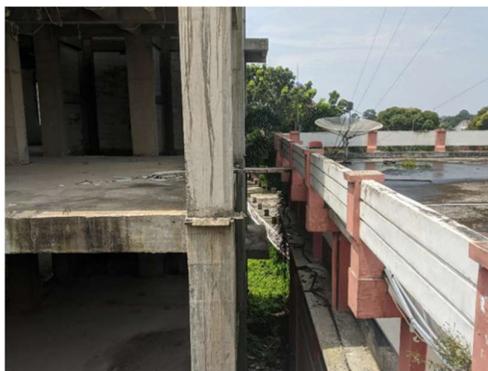
Based on the identification results, the dr Soebandi is adjacent to a new building that is still a concrete frame structure behind the dr. Soebandi hospital. The distance between the two buildings is 1.87m (see Figure 7). The new facility has approximately the same height as the building under review. Based on the FEMA P-154 (2015) book, the danger caused by this adjacency can be in the form of a collision when an earthquake occurs or can cause a fall hazard. The minimum distance between the two buildings is 1" per floor for a relatively high earthquake area. Therefore, the adjacency column does not need to be filled or left blank.

**FIGURE 7.** The distance between dr Soebandi’s hospital with the new building is 1.87 m

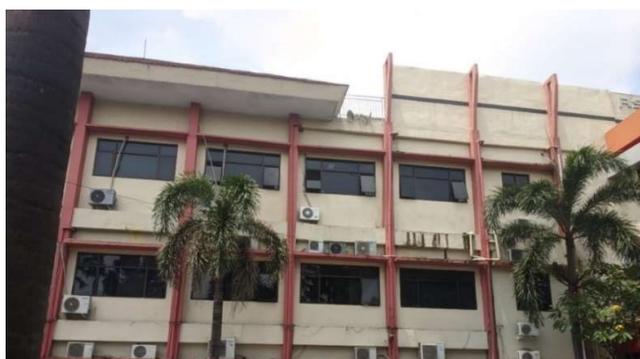
Exterior hazards in terms of non-structural potential to fall on the dr Soebandi hospital is an outdoors fan. Almost every room in the building uses an air conditioner (AC); there are many outdoor on the exterior side of the building (see Figure 8).

**FIGURE 8.** The exterior view that could potentially cause a fall hazard
