THE EFFECTIVENESS OF THE PEDESTRIAN PATH AND RAMP ON JL. IMAM BONJOL CORRIDOR SEMARANG

Hetyorini^{1,a)}, Susmita Eka Mukti², Aziz Maulana³

^{1,2,3}Department of Architecture, Universitas 17 Agustus 1945 Semarang

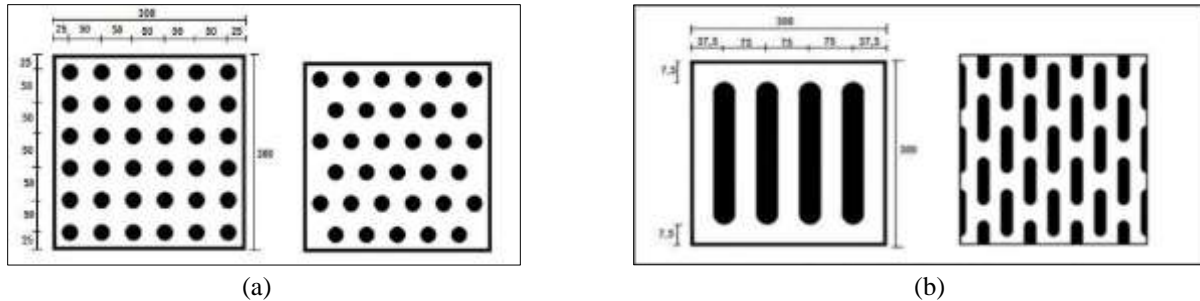
FIGURE 2. (a) Dome tiles/blocks as a warning. (b) Line tiles/blocks as guides.
Source: Ministry of Public Works and Public Housing, 2018

The texture of the directional tiles has a striped pattern that indicates the direction of travel/direction, while the texture of the warning tiles has a circular pattern that warns of changes in the surrounding situation. Areas that must use guiding blocks are areas in front of vehicle traffic lanes, in front of the entrance/exit to and from stairs and at public transportation terminals, pedestrian areas that connect roads and buildings, and in guide directions from public facilities to the public transport station. The following is a guiding tile texture on a guiding block.

In addition to the tile profile or motif, the characteristics of this directional tile are also identified by its color which is generally yellow, although in some countries (such as Australia and Italy) this directional tile uses gray or other colors. The use of yellow was chosen because this color can always be identified (or does not experience significant changes) by everyone, including people with color blindness. Another thing that gives added value to the use of these guide tiles or paths is that these paths are not only beneficial for people with visual impairments, but also for the mobility of elderly who walk (Sari, 2015).

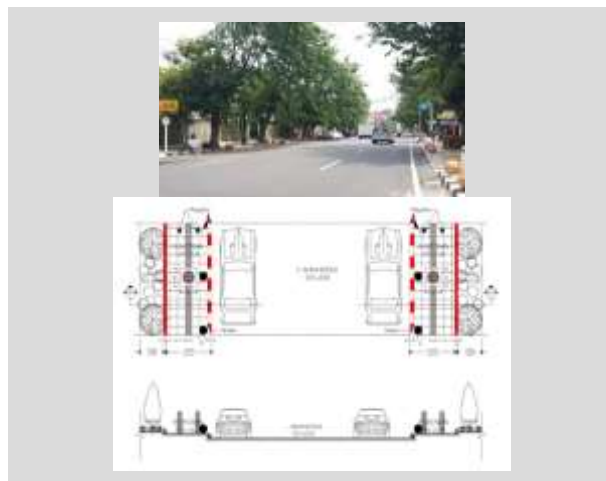
The physical condition of the pedestrian paths on the left and right sides of Jl. Imam Bonjol is quite good, equipped with street furnitures in a well-maintained condition but several sections of the pedestrian path have been damaged. The width of the pedestrian paths on the left and right sides of the corridor is 150 cm - 225 cm, which meets the minimum pedestrian width requirements of the Ministry of Public Works and Public Housing (2018), which is 150 cm wide.

FIGURE 4. Existing sections of the pedestrian path along the left and right of the road corridor.

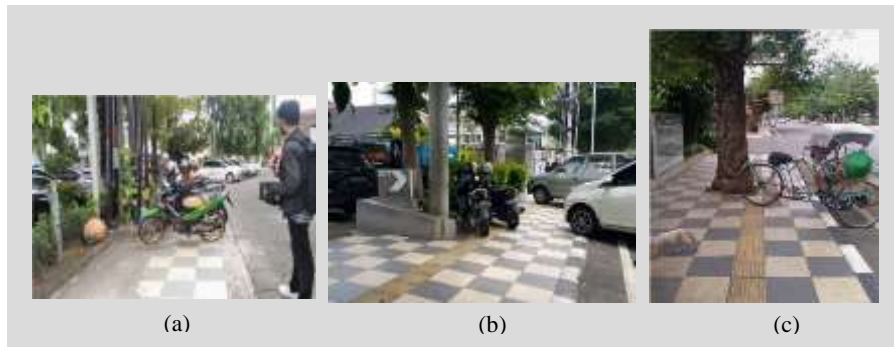
Several sections of the pedestrian path are used for parking motorbikes, cars and tricycles. This is very disturbing for pedestrian path users, especially people with disabilities. The cutting-off of the guiding lane in this pedestrian paths causes discomfort in several sections of the pedestrian paths.

FIGURE 5. The pedestrian path is used for parking for modes of transportation so that pedestrians and people with disabilities cannot access the pedestrian path. (a) Pedestrian lanes are used to park two-wheeled vehicles. (b) Pedestrian lanes are used to park two and four-wheeled vehicles. (c) Pedestrian lanes are used to park pedicabs

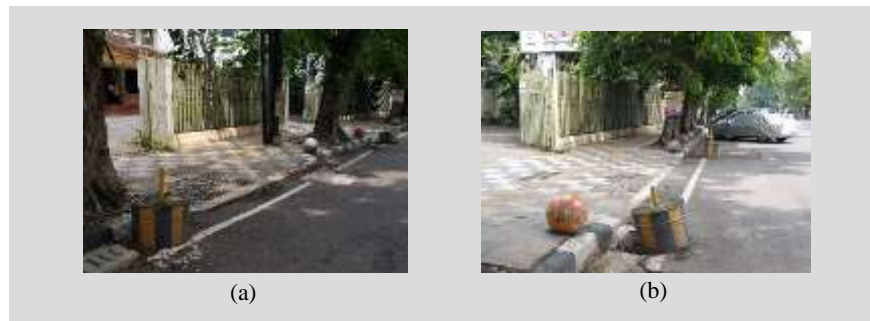
In general, the condition of the ramp along the pedestrian path is in good condition and the slope of the ramp is relatively sloping and meets the allowable ramp slope requirements. However, there are several ramps that are damaged and not repaired. Ramp usually acts as a connecting lane from the main road to the pedestrian path or vice versa. The ramp on the roadway also functions as a freight transport service so that the ramp design must meet the

FIGURE 6. (a) Condition of damaged ramp. (b) The condition of the ramp which is damaged and not repaired.

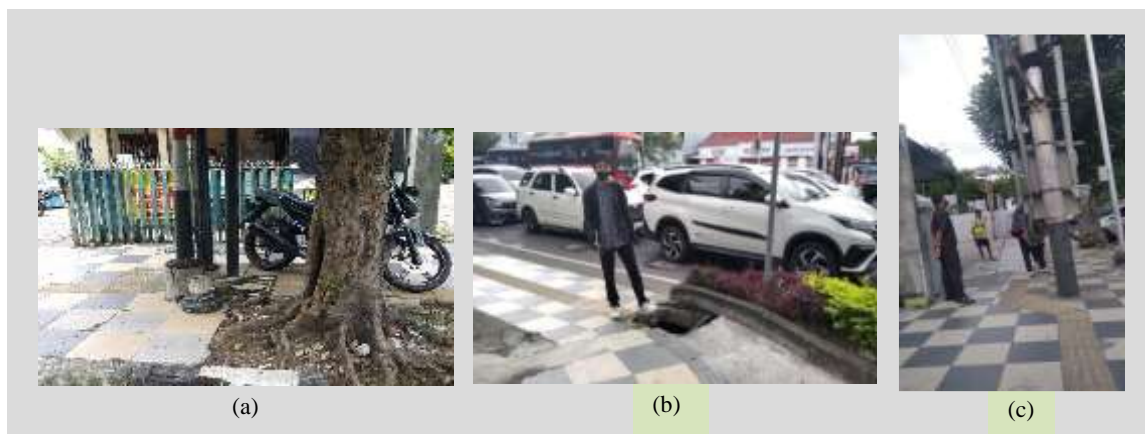
The Imam Bonjol street corridor is equipped with a guiding block. Some of the guideways function properly, but some of them are in damaged condition and even cut off, so that it is very dangerous for pedestrian path users and cannot function as it should. Some of the pedestrian paths are not equipped with guide lanes and are even used for parking motorcycles.

FIGURE 7. (a) The guideway is blocked by trees, utility poles and vehicles. (b) The guideway is interrupted by the channel hole. (c) The guideway is blocked by a power pole.

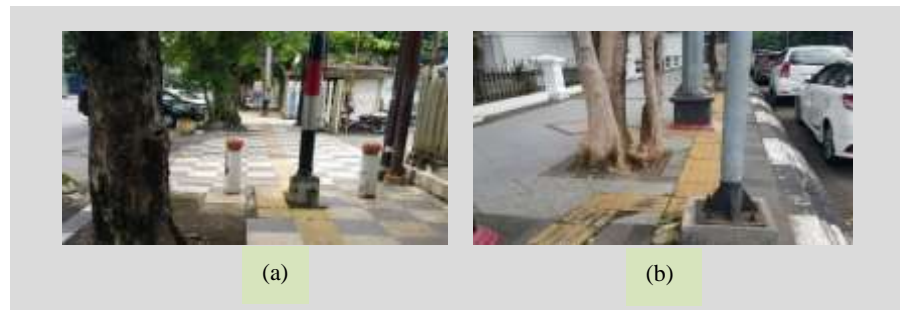
Several conditions of the guideline cause inconvenience and endanger the user because they are designed so winding in following the street furniture on the pedestrian path, and they are placed more close to the main road. With a comfortable enough width of the trottoir, the guide lines should be placed adjacent to the building fence so that the blind can move more freely and safer. Pedestrians and people with disabilities have the same rights in accessing public spaces. The guide path that causes inconvenience, especially for people with disabilities, can be seen in the following figure.

FIGURE 8. (a) The guideway is blocked by electric poles so that the blind, pedestrians with crutches and persons with disabilities in wheelchairs cannot access the pedestrian path. (b) Placement of guide lines that are crooked and inhumane.

Placement of guide lines is not effective, especially at meetings with pedestrian path facilities such as electric poles, lighting lamps, bollards, and trees so that the design of the guide path is winding and does not meet the minimum space requirements for movement and makes it difficult for persons with disabilities to move. Some parts of the ramp facilities on the pedestrian path need to be repaired, while the ramp is quite safe for users. Pedestrian service in Jl. Imam Bonjol corridor as a whole can be said to be less effective for people with disabilities.

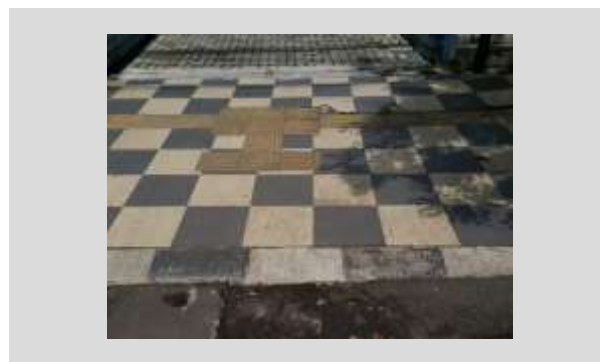
FIGURE 9. The guideline which is located on the ramp is still in good condition and the ramp has a height according to the provisions.

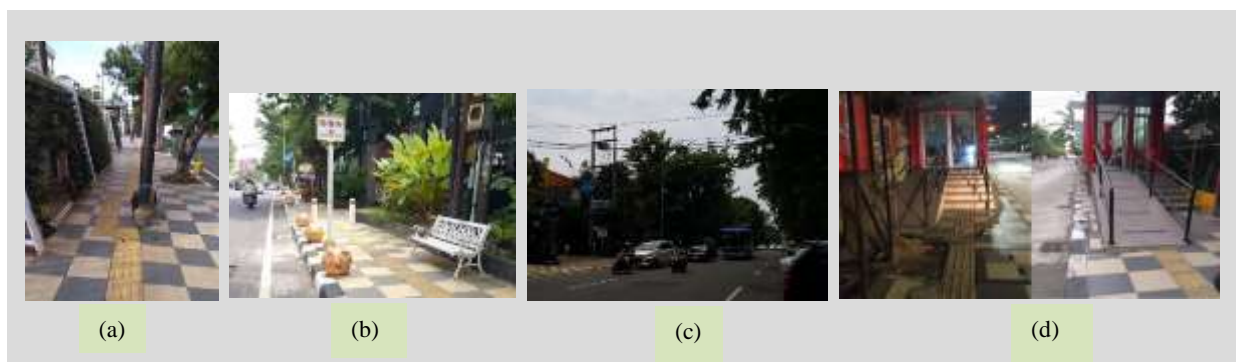
The pedestrian path is actually equipped with guideline facilities, benches, street lighting, bus stops, bollards, vertical gardens, plants or trees, but it appears that some of these facilities are not maintained.

FIGURE 10. Facilities on pedestrian paths. (a) Vertical garden with unkempt condition and some damaged. (b) Benches, bollards, signs and plants. (c) Street lighting. (d) Bus stop (placement closes the pedestrian path).

From the observation and analysis of pedestrian paths along Jl. Imam Bonjol Semarang and by considering the related regulations, it can be seen that the width of the pedestrian paths on the left and right corridors of Jl. Imam Bonjol has fulfilled the requirements. Meanwhile, the placement of bus stops are not quite proper, because they use the entire width of the sidewalk so that user circulation is cut off and this placement is not in accordance with government regulations. The inaccuracy in the placement of bus stops is caused by the presence of pedestrian paths that are available first and then the need for bus stops arises.

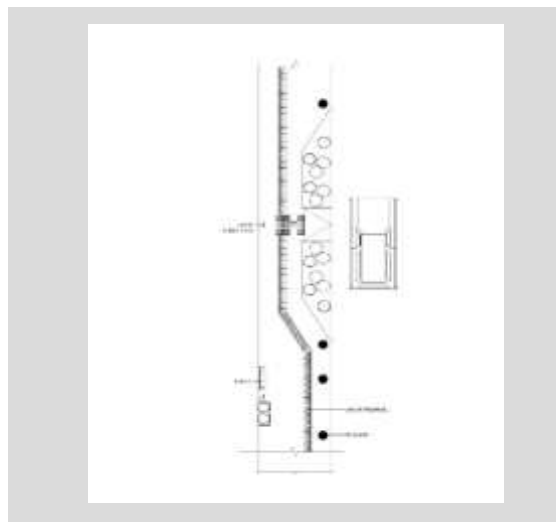
FIGURE 11. *Alternative design on the pedestrian path with a garden on the front which borders the road and is placed on the left and right sides of the ramp.*

Design alternative 1 is planned by considering the needs of pedestrians with normal physical conditions and pedestrians with special needs such as the blind, pedestrians with crutches and wheelchair users. The user's movement space is a design consideration, especially the space for people with disabilities and the provision of bench facilities, lighting and trash cans.

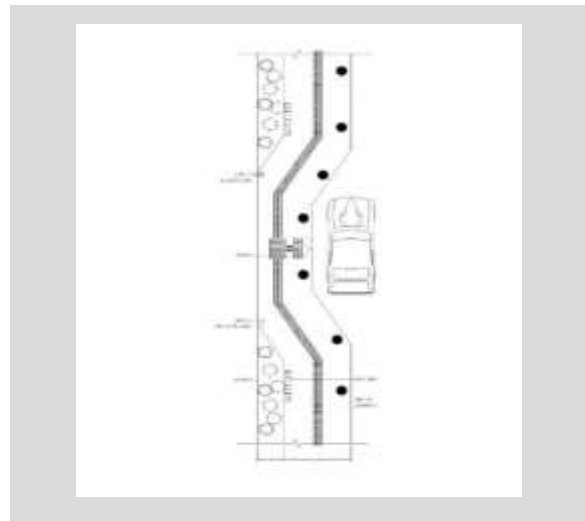
FIGURE 12. An alternative design on the pedestrian path by placing warning tiles at the end of the crossing area on the pedestrian path with vehicle stop niches.

Design alternative 2 is applied to pedestrian paths with vehicle-stop niches, namely by placing warning tiles on the ramp. This design considers the safety of the disable person in transferring to modes of transportation on pedestrian paths and creating convenience along pedestrian paths. Placement of benches and other facilities on the crossing paths is also considered to provide comfort and smooth activities on the pedestrian paths.
