The Impact of Market Relocation to Roadway and Sidewalk Functions at Patiunus Street Pekalongan

Azhar Hasna Rany^{1, a)}, R. Siti Rukayah², Suzanna Ratih Sari²

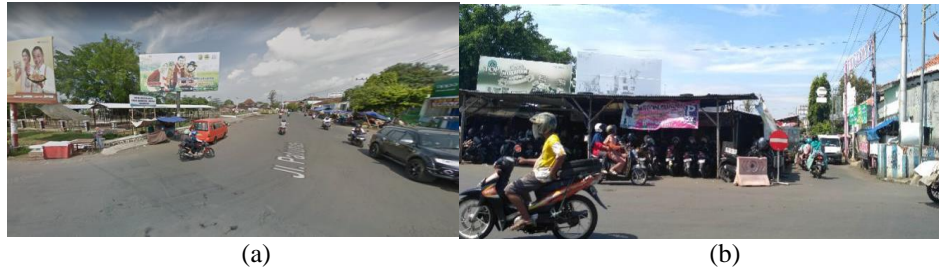
FIGURE 1. Patianus street before (a) and after (b) Banjarsari Market relocation
(Source: Researcher Documentation, 2019)

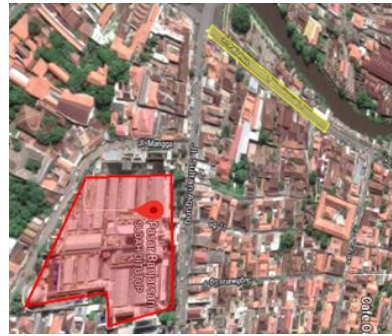
FIGURE 2. Map of Banjarsari market before conflagration (red line) and Patianus street (yellow line).
(Source: Google Maps)

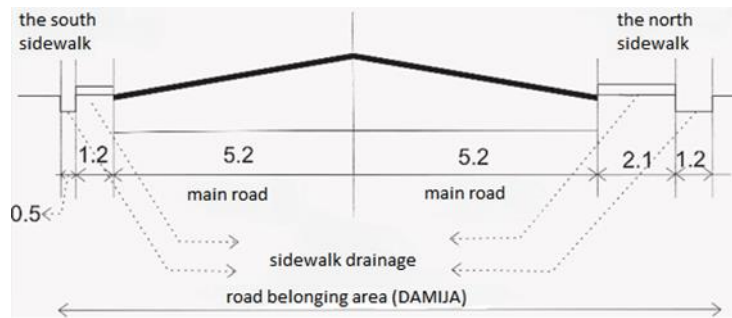
Patianus street serves the public transportation route. This route can be elaborated as follows Sayun-Slamaran (round trips) as secondary taxi or van-stop. Patianus is a two-way road with medium categories (length 544 m; width 15 m; lane 11,4 m; left pavement 1,2 m; right pavement 2,1 m; left road tunnel 0,5 m; and 1,2 m of right road tunnel) [12].

FIGURE 3. The Roadway Cross at Patiunus street
(Source: Researcher's Analysis, 2019)

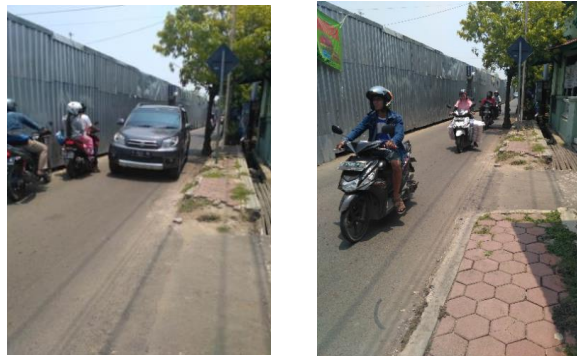
FIGURE 4. Vehicles which passed Patiunus Street
(Researcher Documentation, 2019)

Until 2020, Patiunus street was inaccessible to freight cars, and garbage trucks needed to turn around for picking the trash. Traffic Jammed became familiar to the people in passing this street, and the alley of Patiunus street transformed to be the shortcut route show in Figure 4. The urban accessibility function tended to decrease and spent more time to pass this street because of Banjarsari market relocation.

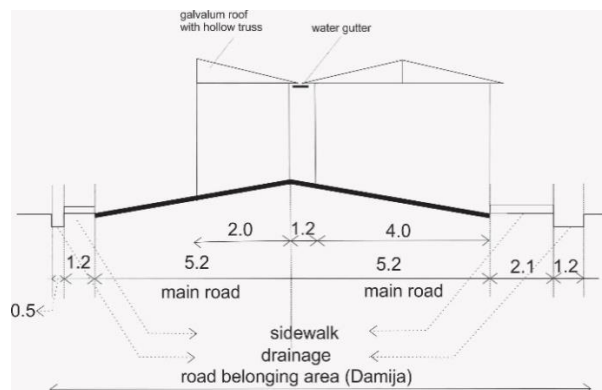
The relocation of Banjarsari market took more than half of the main road and the road space. Figure. 5 shows the north sidewalk and Patiunus Parking area achieved the standard regulation of the sidewalk (right side of Figure.5). However, this part was used to relocate the Banjarsari market. The north sidewalk had 2 metres of width, and the south sidewalk was less than 1 metre of width. Furthermore, there was a section of unavailable sidewalk near the market on the south sidewalk of Patiunus street (left side of Figure.5)

FIGURE 5. The illustration of Banjarsari market relocation at Patiunus street
(Source: Researcher's Analysis, 2019)

Figure 5 shows the road part of Patiunus street according to [15]. Then, add by the illustration of temporary stands for Banjarsari market relocation. The north side of Patiunus was covered by stands, while the south sidewalk was covered by many potholes and non-standard. It causes the pedestrians and visitors to use the main road of Patiunus street.

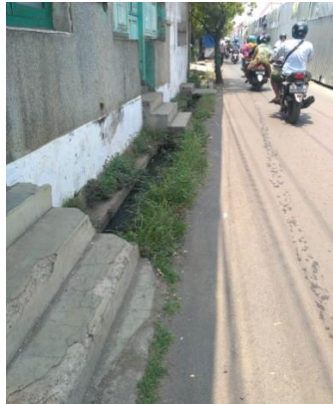
FIGURE 6. The North Sidewalk Condition at Patiunus Street
(*Researcher Documentation, 2019*)

The sidewalk of Patiunus street was covered by the Banjarsari market, and it was the south sidewalk remaining as shown on Figure 6. This situation did not meet the sidewalk criteria proposed by [2]

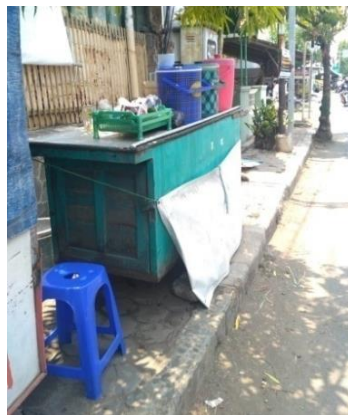
1. **The balancing interaction between the pedestrians and the vehicles.** Figure 7 shows that the pedestrian prefers to use the main road to avoid the potholes and street vendors that utilized the sidewalk.

FIGURE 7. Street Vendor at the south sidewalk of Patiunus street
(*Researcher's Documentation, 2019*)

2. **Safety factor**, adequate space for pedestrians. The pedestrians at Patiunus street were not safe since there were many street vendors and potholes that need some improvements. The north sidewalk of Patiunus street had 2 metres of width. On the other hand, the south sidewalk had 1 metre of width, and some of the parts did not have a sidewalk. Most of the drainage at Patiunus street was broken, which caused a flood when the rainy season comes. Furthermore, the puddles can overflow and cover Patiunus street. This condition in Figure. 8 weakens the pavement structure and the safeness of visitors.

1. The improvements of the sidewalk at the south park and redesign for the street vendor are required. It aims to prevent visitors and pedestrians for not using the main road to walk. It brings safety and comfort to them and could decrease the number of accidents in Patiunus street.
2. The government may change the road status from secondary collector street to secondary street if the market is overflowed and crowded.
3. A proper drainage system needs to be planned since the water is overflowed and results in puddles. It is urgent to be solved since it disturbed the surface course of pavement structures.

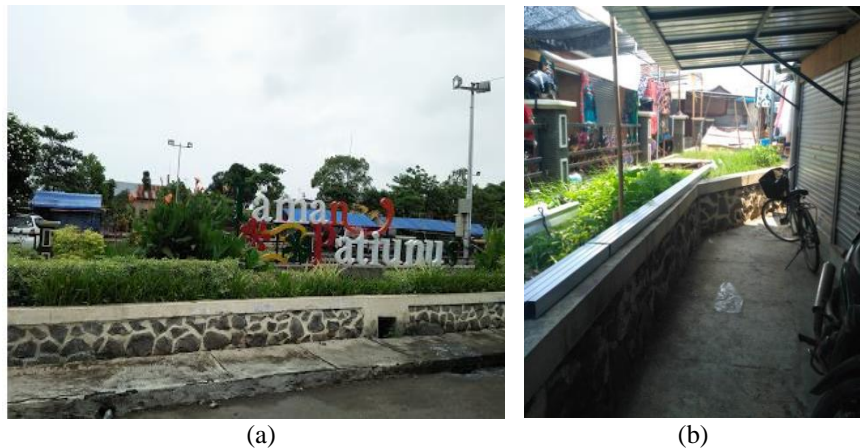
3. **The facilities offered a pleasurable experience on the sidewalk.** There were many trees on Patiunus street. Unfortunately, there were not sufficient street signs for the disabled person. Furthermore, the quality of the sidewalk needed some improvement.
4. **The availability of public facilities unites and becomes supporting elements of the sidewalk.** In the beginning in Figure 9 a) several facilities support Patiunus streets like parks and benches. However in Figure 9 b) those facilities cannot be used after the relocation of the Banjarsari market.

FIGURE 9. Patiunus Parking Area (a) before relocation, (b) After relocation Banjarsari market.
(*Source Google Maps and Researcher's Documentation, 2019*)
