## Evaluation of Building Vulnerability to Earthquake Using Rapid Visual Screening (RVS) Method

Based on the above background, the building's vulnerability evaluation to earthquakes using the Rapid Visual Screening (RVS) method applied to a case study of the building dr. Soebandi Jember. So the vulnerability building to earthquakes or safe against earthquakes can be known.

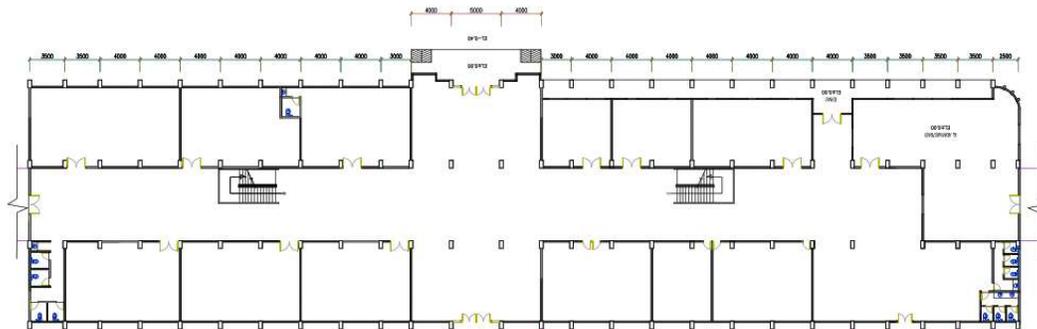
**FIGURE 6.** The floor plan of dr Soebandi's building (Source: Documentation of RSD dr. Soebandi)

Based on the identification results, the dr Soebandi is adjacent to a new building that is still a concrete frame structure behind the dr. Soebandi hospital. The distance between the two buildings is 1.87m (see Figure 7). The new facility has approximately the same height as the building under review. Based on the FEMA P-154 (2015) book, the danger caused by this adjacency can be in the form of a collision when an earthquake occurs or can cause a fall hazard. The minimum distance between the two buildings is 1" per floor for a relatively high earthquake area. Therefore, the adjacency column does not need to be filled or left blank.
