## Comparison of Sentinel-1A Ascending and Descending Image Processing Results on the Tukul Dam Using SNAP Software

Faiz Mahbubi<sup>1\*</sup>, Sukamta<sup>2</sup>, Yudo Prasetyo<sup>3</sup>

<sup>1,2</sup> Department of Civil Engineering, Faculty of Engineering, Diponegoro University, Indonesia

This study analysed and compared the accuracy of the results of Sentinel 1A satellite image processing in the ascending and descending orbit directions with SNAP software. The research is located at Tukul Dam, Karanggede Village, Arjosari District, Pacitan Regency, East Java Province, with a range of observation data for one year in 2022-2023. Sentinel 1A satellite image processing uses the Differential Interferometry Synthetic Aperture Radar (DInSAR) method. The results of Sentinel 1A image processing were validated using measurement data from 38 dam surface measurement points that had been measured terrestrially. The accuracy calculation uses the Root Mean Square error (RMSe) to measure the vertical movement of coordinates (Z) from the results of Sentinel 1A image processing in the ascending and descending orbit directions with the actual position in the field measured terrestrially. Th

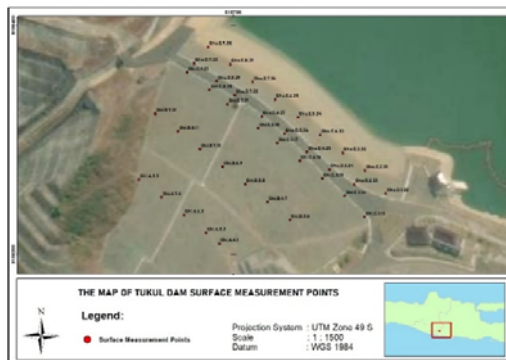
**Figure 3.** Distribution Map of Tukul Dam Surface Measurement Points

The data needed to obtain the displacement value of the Tukul Dam body include terrestrial measurement data of the shear peg instrument on the dam body, Sentinel 1A image data in the ascending orbit direction and Sentinel 1A image data in the descending orbit direction at the research location. Measurement data of dam body shear stakes were obtained at 2 observation times in approximately one year, namely in March 2022 and April 2023 as shown in Table 1. Sentinel 1A image data in the ascending orbit direction and Sentinel 1A image data in the descending orbit direction were also downloaded for approximately one year and adjusted to the time of surface measurement points measurement. The distribution of the Tukul Dam surface measurement points can be seen in Figure 3.

The instrument contained in the Tukul Dam totalled 38 surface measurement points. In the upstream part of the dam body, there are 8 points, at the top of the dam body there are 18 points, and in the downstream part of the dam, there are 12 points. The surface measurement points are routinely observed using the Global Navigation Satellite System (GNSS) Real-Time Kinematic (RTK) method.
